Journal of Applied Materials Engineering

2019, Vol. 59, Issue 2

Assessment of cast-on-strap joints of lead acid batteries

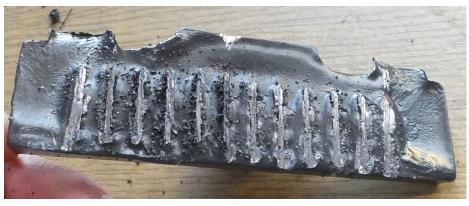
Fig. 3. The cast-on-strap positive and negative joints of a lead acid battery [photo E. Jankowska]

In the first part of the study, bridge connections were selected from cells of lead acid batteries with different nominal capacities. The samples to be tested were taken from new lead acid batteries available on the market. The lead acid batteries were brand new. They were not laboratory tested. Examples of bridge connections from selected battery cells are shown in the Figure 3.

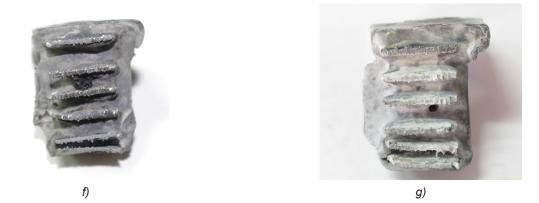
Fig. 4. The examples of cast-on-strap joints of plates, negative – a), c), g) and positive – b), d), e), f) [photo E. Jankowska]
